4-1-2 Preservation and Restoration Project for Important Cultural Properties in Japan Mikawashima Sewage Disposal Plant and Pumping Station Facilities, National Important Cultural Assets

1. Overview of former Mikawashima Sewage Disposal Plant and Pump Station Facilities

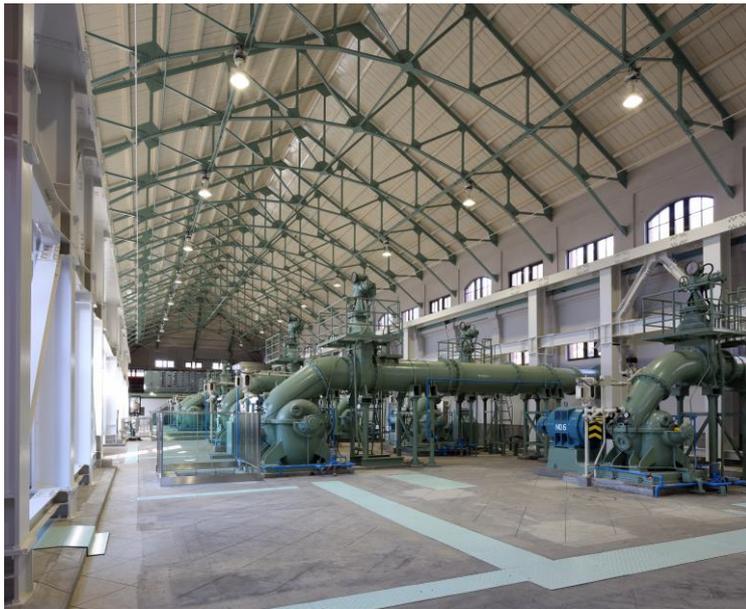
Figure2 Inside of the pump house of the former Mikawashima Sewage Disposal Plant

The building was used to house pumps that lifted wastewater in preparation of starting full-scale treatment. Outer wall of the building, covered with elegant, classic red brick tile, is attractive to visitors. During our restoration, part of damaged brick tiles was replaced with new ones. To reproduce original taste as much as possible, a detailed research was made to clarify the original tile used there. In addition to the above, part of pumping facilities were restored and repaired to maintain the existing conditions.
